Corrosion Survey Report

Vessel Details		Name MY "XXX"
Manufacturer Bayliner		Model 4387 Aft Cabin
LOA [Ft] 44	Year 1993	Hull Material Fiberglass

Report No 2017/0031
Date 28.09.2017

Reason for Survey Diver reports corrosion on engine inlet strainers
--

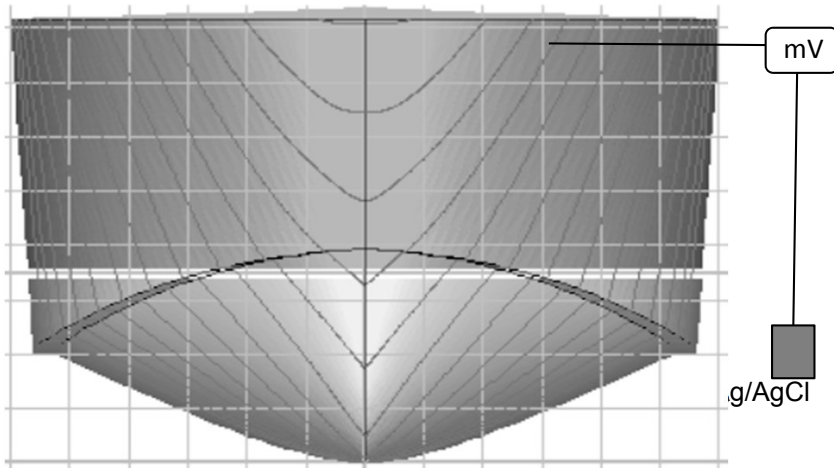
Hull Potential and Bonding System

Hull Potential Readings 1)

Aft	450
Amidships	X
Bow	X

Bonding installed	Yes
Galvanic Isolator	No
Isol. Transformer	No
Faults detected	Yes

Bonding not soldered or sealed and heavily corroded. Bonding wire broken between both engines and cooling intakes. Approx. 10 cm of water in Bilge. Aft bilge pump shows stray current readings of 1,023-1,030 Volts when in operation. Stbd. shaft packing leaking.

Rebonding of all UW through Hulls required!.
Solder and seal all bonding connections.
Re-wiring of AC ground to DC bonding required.
Renew aft bilge pump (isolation defect).
Renew both engine inlet strainers! High Safety Risk!

Not mandatory: Corrosion Controller recommended
